Revised 1/14/94 Destroy all previous copies

HP AT 145 and HP AT 158 gliders delivered before July 1st, 1990.

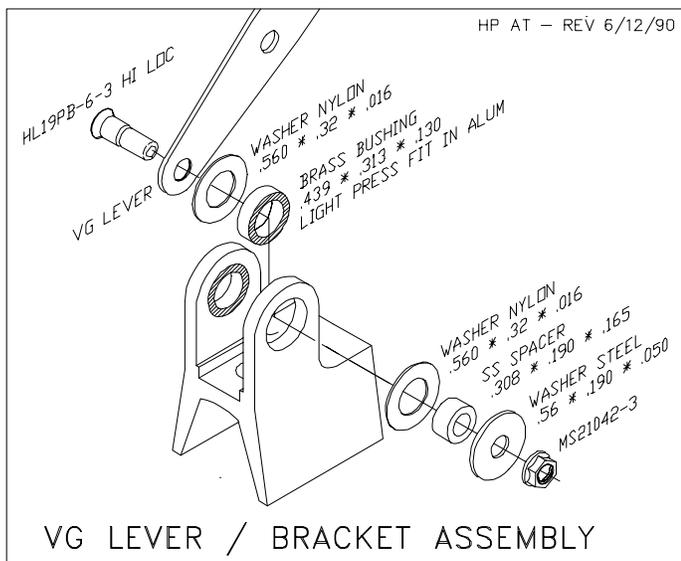
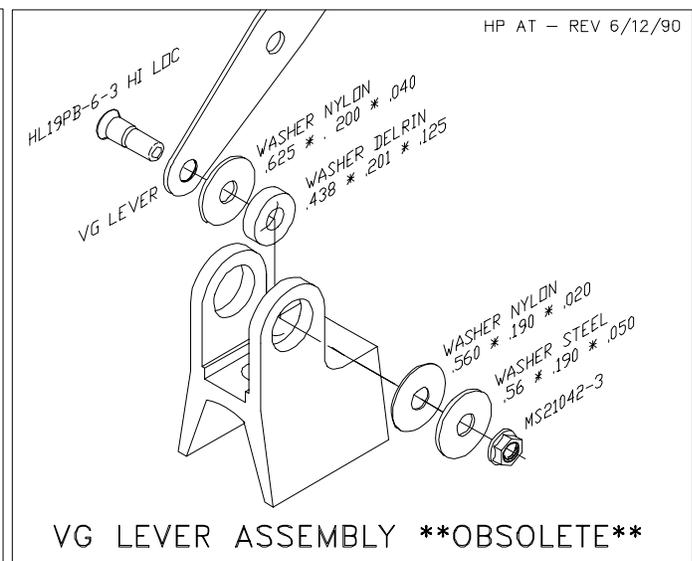
All HP ATs delivered by Wills Wing before July 1st, 1990 were produced with the VG Lever Assembly shown below in the figure labeled "Obsolete". These assemblies were subject to two maintenance problems: first, the inner delrin bushing deteriorates prematurely increasing VG activation forces and play in the lever assembly; second, the 3/16 clinch nuts sometimes loosen and fall off rendering the VG mechanism inoperable. We have designed a retrofit assembly which addresses both of these problems and is simple to install.

Instructions
