Applies To:

RamAirs produced after January, 1994, and replacement of kingpost VG compensator pulleys on all RamAirs and all HP AT's.

Pulley Design Change:

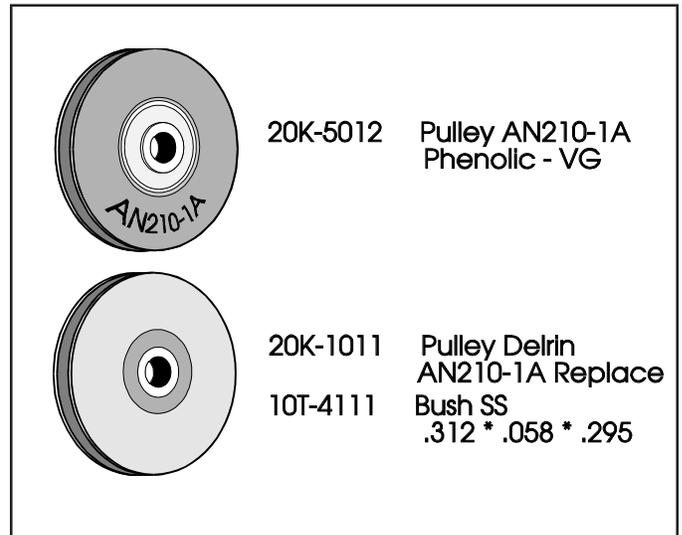
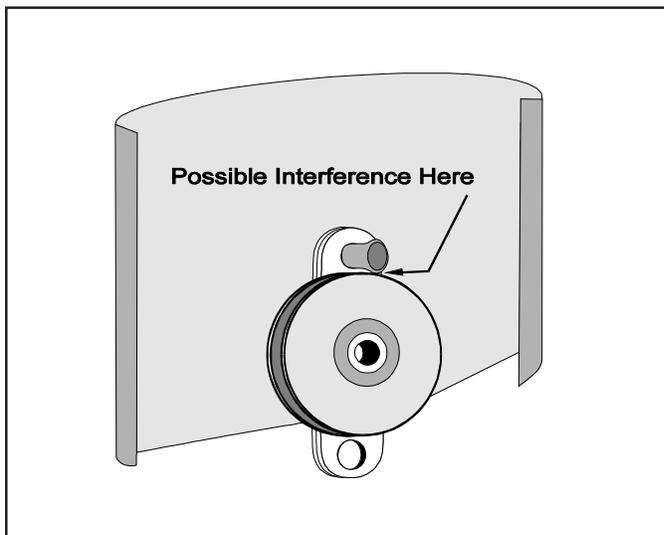
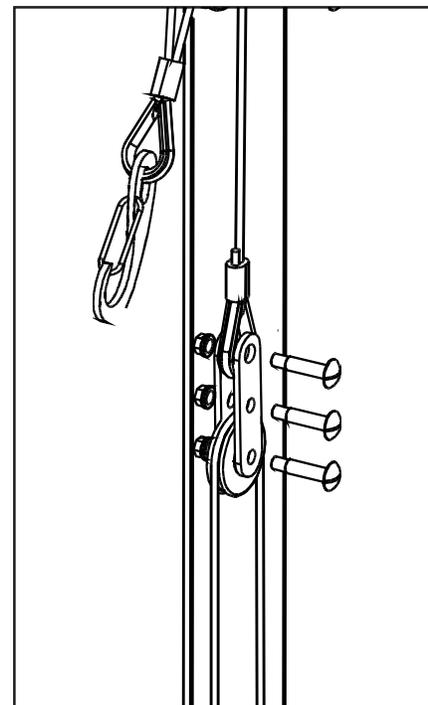
The original phenolic pulley used in all kingpost compensator systems (top right) is being replaced by a new molded plastic pulley (bottom right). Please take note of the following service related concerns regarding the new pulley:

1) The new pulley consists of two parts as indicated - the molded plastic pulley and a press fit stainless steel bushing reducer. In the new pulley, the mounting bolt passes through this press fit bushing, instead of through a free spinning bearing race as on the original. As a result, in the assembly shown in the bottom right diagram on this page, (any VG kingpost) you must be careful not to overtighten the bolts securing the pulley between the tangs.

Otherwise, the tangs will clamp on the bushing, and the pulley will not turn freely.

2) The new molded pulleys have some degree of variation in the outside pulley diameter. This is not a problem in most applications. However, in the kingpost bottom assembly of the early RamAirs, in which the two pulleys are mounted to tangs which are in turn mounted to the kingpost tube, the outer edge of this pulley passes very closely by the rivet which secures the upper end of the tangs in the bottom of the kingpost tube. As a result, there may be interference between the pulley and the rivet head. If you need to install the new style pulleys in an old style kingpost, you may need to turn down the outer pulley diameter slightly. This can be done by using a 3/16" bolt to chuck the pulley in a hand held drill, and spinning the pulley against an abrasive surface.
