Revised 1/14/94 Destroy all previous copies

All layflat hardware style gliders (including the RamAir) utilizing the keel track / slider control bar apex system.

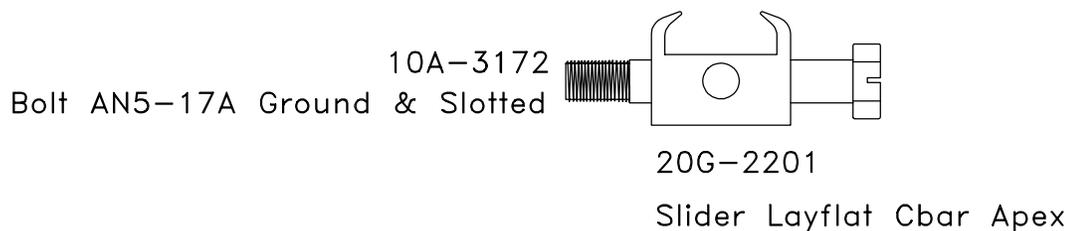
OLD STYLE

In November, 1993 there was a design change to the control bar apex slider. The purposes of the design change were to improve the slider's resistance to damage in hard landings, to improve the retention in the slider of the plastic glide strips, and to reduce the chance of fatigue on the swan wire where it exits the front of the slider. The new slider is wider, increasing the thickness of the upper ears, and making them less likely to bend open as a result of a hard landing impact transmitted through the control bar. The new slider is extended in the front so that the slider contacts the stop bolt directly instead of via the edge of the plastic glide strip, and the slider now has a retaining slot in the front for the bottom plastic glide strip. Finally, the exit hole for the swan wire is extended and has an internal radius to reduce the chance of wire fatigue.

The new style slider, because it is wider, requires a longer bolt (see diagram above). If you are replacing a swan wire on an early model (manufactured before November of 1993) you must also order a new, longer bolt, as shown above.
