RamAirs produced after January 1994, and replacement kingpost orders for earlier RamAirs.

RamAir Kingpost Design Change:

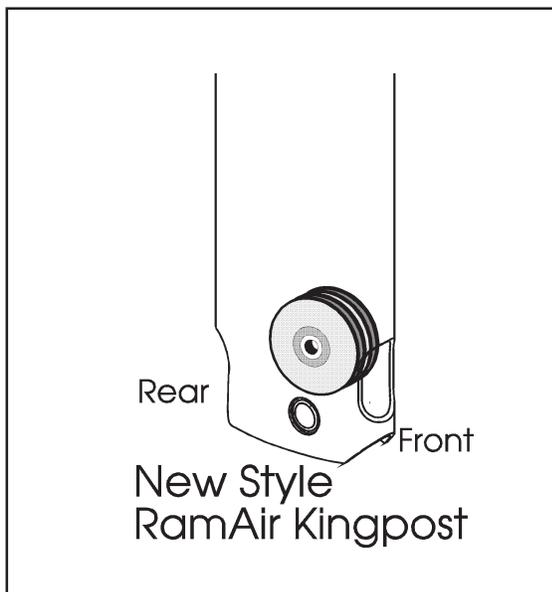
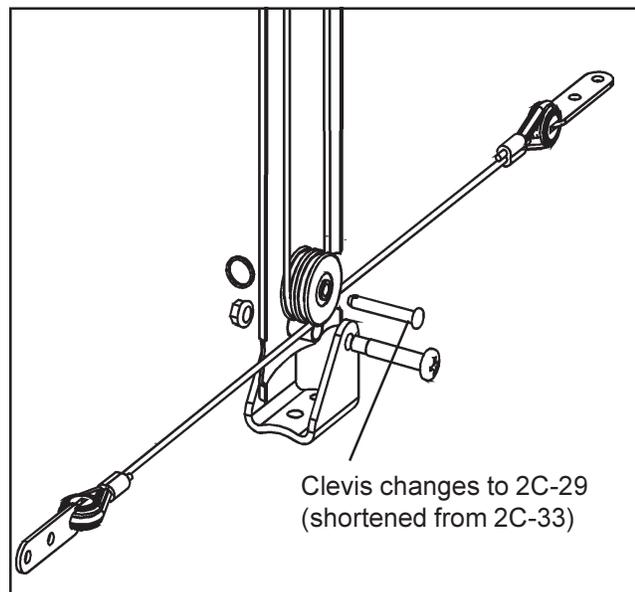
The base of the RamAir Kingpost has been redesigned as indicated in the drawing below left. The bottom of the kingpost has been extended downwards, and the four tangs which previously mounted the pulleys to the kingpost and the kingpost / pulleys assembly to the kingpost base bracket have been eliminated. The pulleys now mount directly into the kingpost base, and the kingpost bolts directly to the kingpost base bracket via a bushed hole in the bottom of the kingpost tube. Slots are cut in the front and rear of the bottom of the kingpost for the lower compensator wire to pass through. The new style kingpost can be used as a replacement part on any RamAir, and the original style kingpost has been discontinued. All pulleys, cables and other fittings are compatible with the new style kingpost, except that the clevis pin which secures the pulleys in the kingpost base should be changed as follows:

The reason for the substitution is that the installation of the four pulley mounting tangs inside the old style of kingpost slightly increases the width of the kingpost, while the installation of the bushing in the new style kingpost slightly compresses the width. If the original longer clevis is used on the new style kingpost, the head can project away from the surface of the kingpost and the sweep wire can become snagged on the head of the clevis.

Original Part:	10G-1330	CLEVIS PIN MS20392-2C33
Replacement:	10G-1290	CLEVIS PIN MS20392-2C29

Other than the clevis substitution and the elimination of the four tangs and the pop rivets which secured them into the kingpost, there are no other required substitutions in the parts used in the assembly.
